NATIONAL PROGRAM FOR INSPECTION OF NON-FEDERAL DAMS  
NORWICH RESERVOIR DAM. (U) CORPS OF ENGINEERS WALTHAM  
MA NEW ENGLAND DIV AUG 81

NORWICH Reservoir DAM

Overview of Dam

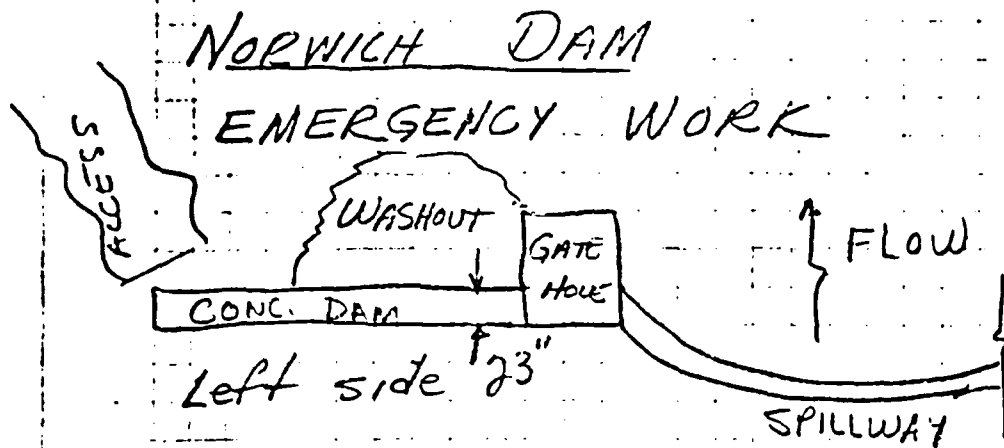
WASHOUT =  $30' \times 30' \times 6" \approx 200$  cubic yards

Replace washout immediately to provide  
access to Gate House & insure stability  
of 23" Concrete wall.

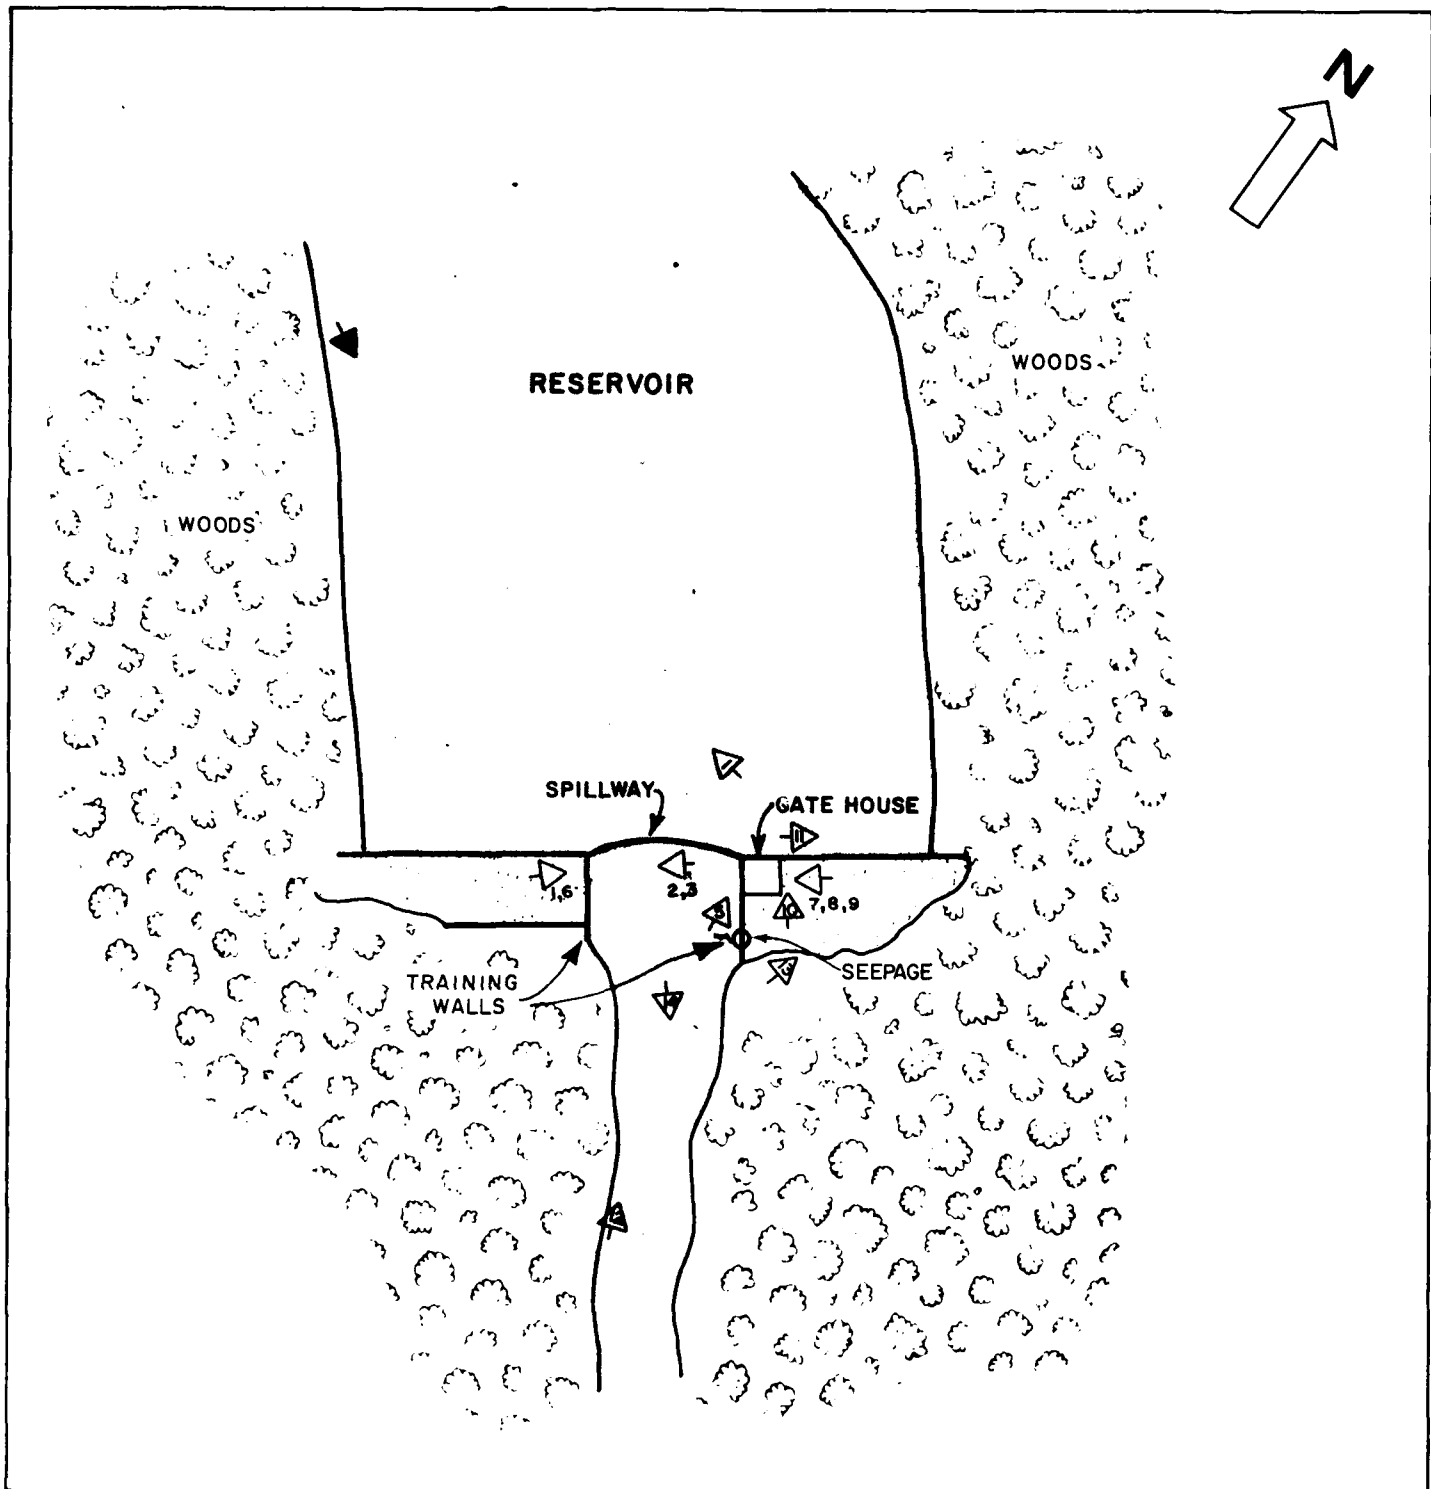
- OVERVIEW PHOTO  
 ▷ APPENDIX C PHOTO

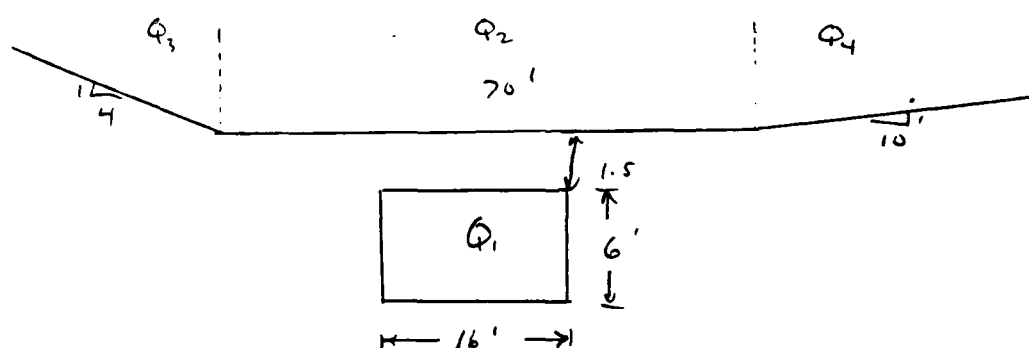
At the end of the 4,000 foot reach, Brown Brook flows through a 16 foot wide by 6 foot high culvert with a low chord 1.5 feet lower than Beaver Meadow Road. Although the attenuated stage is about 7.2 feet, the peak flow of 6,000 cfs would quickly fill the culvert beyond its capacity and raise the peak stage considerably. Shown below is a cross section of this culvert.

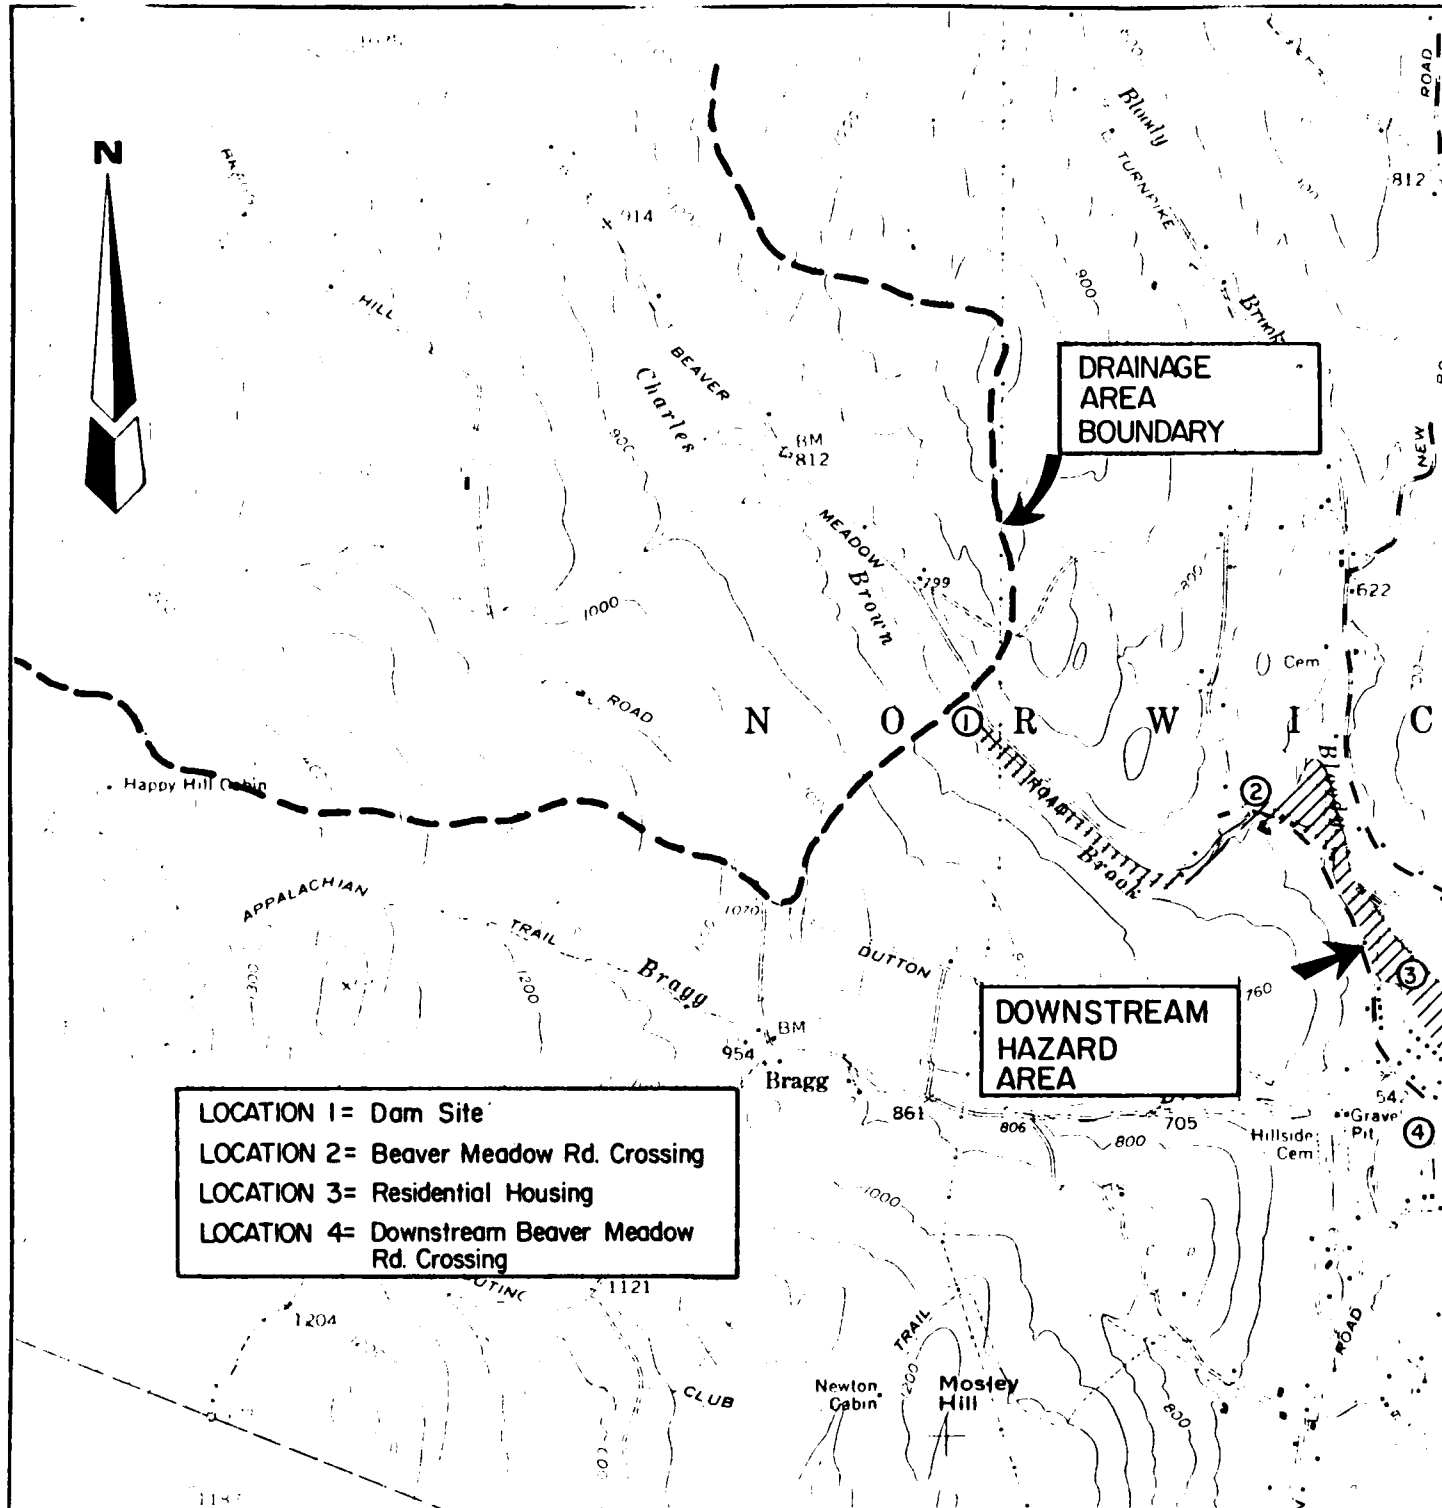
- LOCATION 1= Dam Site  
 LOCATION 2= Beaver Meadow Rd. Crossing  
 LOCATION 3= Residential Housing  
 LOCATION 4= Downstream Beaver Meadow Rd. Crossing
